# HANDS ON

# *REVITALISING BUILDING ARCHAEOLOGY*

**Thomas Hacksen Kampmann.** As the looming climate crisis is becoming directly apparent to most people, there is an increasing focus on how our buildings affect nature. This raises the question of whether it is better to demolish the existing buildings and replace them with new low-energy buildings or gently insulate the old buildings. Of course, they will have a higher energy consumption for heating, which is increasingly covered by renewable energy, but on the other hand they have already strained nature during construction perhaps many years ago. Lifespan is therefore a very important parameter for assessing the overall environmental impact. Restoration architects are used to researching existing buildings to find out when they were built and what alterations they have undergone in the period up to now. This article attempts to investigate whether such archaeological investigations can be helpful in assessing the future lifetime of buildings for use when making overall Life Cycle Assessments.

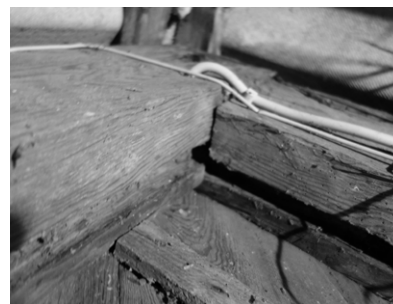
**Figure 9:** Construction detail at north-western gable. Here, the rafter is made from pinewood and provided with a groove originally intended for the attachment of gable boards. The pinewood rafter is typical to roof constructions and in contrast to the other rafters, presumably made from poplar. Photo, Thomas Kampmann, 2019.

established that the boards had not originally been nailed on the outside but instead notched into a groove in the rafters themselves. (Fig. 9) No timber marks were found on this rafter, but the next rafter had 'VI' scratched into the wood. (Fig. 10) This rafter and the next ones were all numbered in a descending scale down to No. I. The rafters were roughly processed with an axe and not made from pine, as is normal practice, but presumably made from poplar. The collar beams that were preserved were also numbered and made from the same type of wood as the rafters. (Fig. 11)

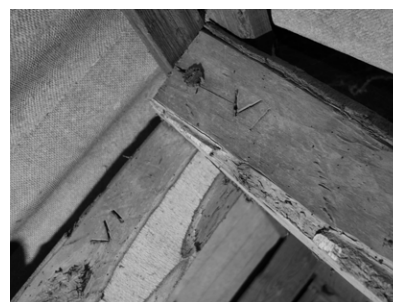
**Figure 10:** The top joint of rafters in the roof construction in the apprentice house. The timber mark, here on rafter no. VI, indicates a seven-bay house of two gable in pinewood rafters and 6 numbered rafters in between in poplar. Photo, Thomas Kampmann, 2019.

Following rafter No. I came another pinewood rafter, as with the first pinewood rafter with no visible timber marks. This matched the description from the archive of the original seven-bay house – two gable rafters without a number and six numbered rafters in between – and exactly matched the extent of the boulder foundation on the north-eastern side. (Fig. 17) The next rafter was another unnumbered pinewood rafter ending with a stronger pinewood rafter at the south-eastern gable.

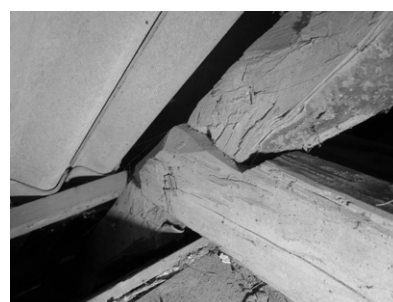
**Figure 11:** Joint between rafter and collar beams. The rafter and the collar beams are made from the same type of wood. Photo, Thomas Kampmann, 2019. **Opposite page top, figure 6:** Elevation SW **Opposite page middle, figure 7:** Section BB **Opposite page bottom, figure 8:** Plan, ground floor

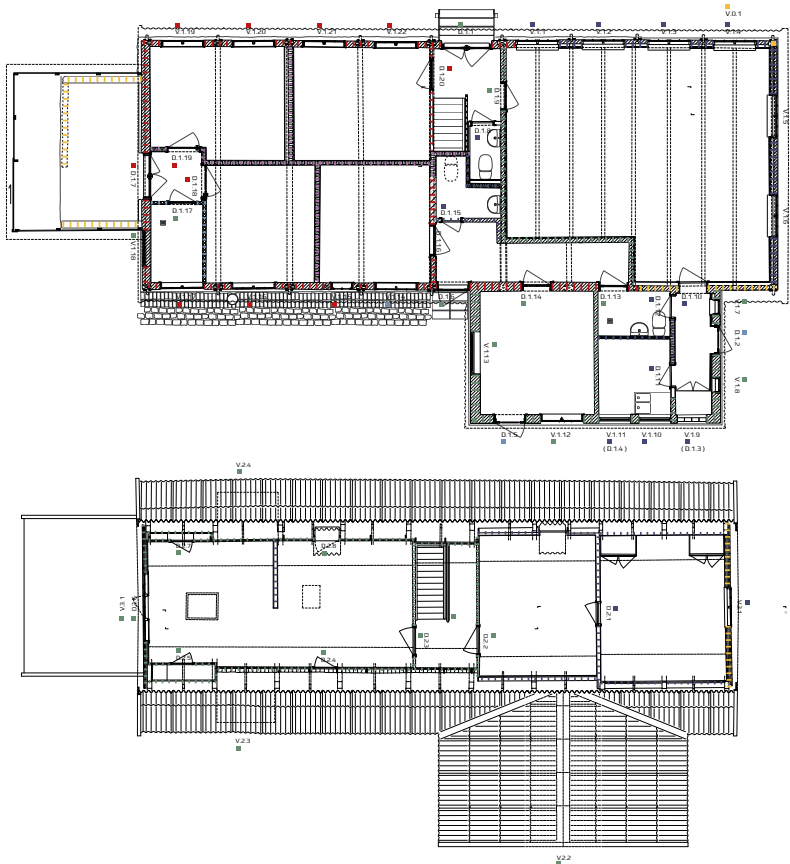
**Above, figure 12:** Historical building changes over time. The colours on walls, doors and windows indicate how old they are – the red ones are the original from 1887, the orange are extensions from about 1895, the green from after 1916, the blue ones from after 1947, indigo from 1967, and purple is 1970s remodelings.

All the original building parts that have been preserved are thought to have a high architectural and technical value, whereas most of the redevelopments that took place in the 1970s and later are very unfortunate and therefore recommended for removal.

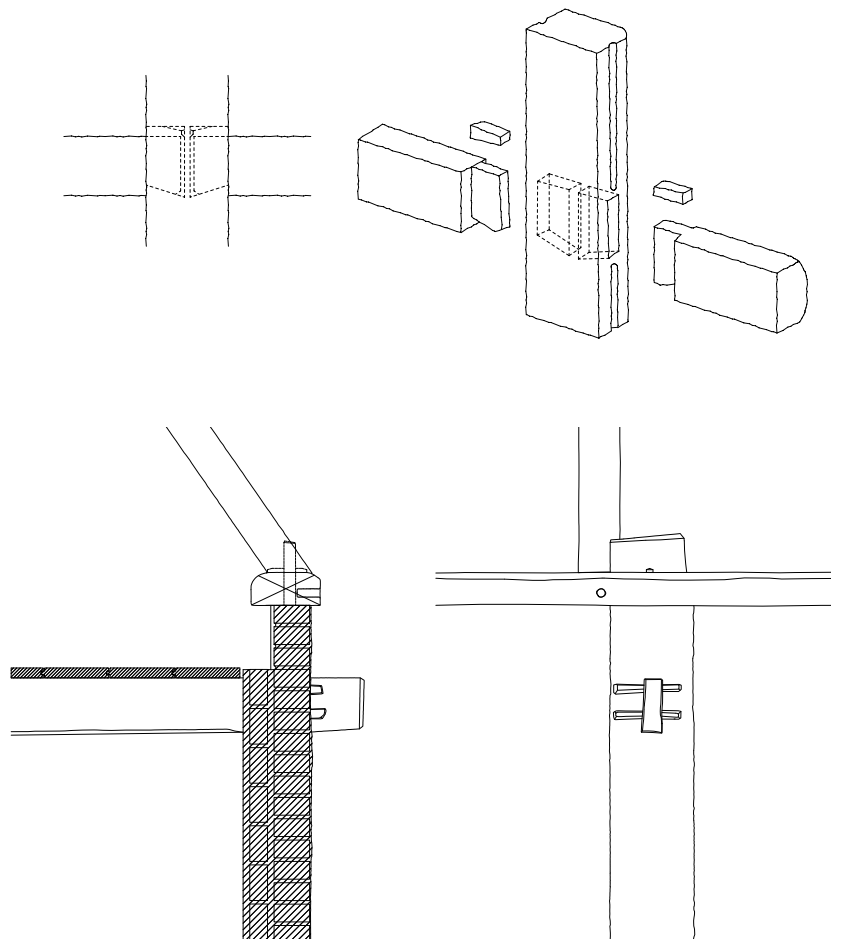
Timber-framed buildings are normally assembled with interties, the horizontal pieces of timber between the posts just below the windows, joined by tenons and pegs, but in this house there was only one single peg. It turned out that the interties were attached according to a rather special method known at Bornholm from the 1840s.<sup>1</sup> (Fig. 20)

Above top, figure 20: Detail of post, the vertical piece of timber is supported by two interties. These are kept in place by the tenons being inclined at the bottom and then locked with wedges at the top. This is a rather unusual construction, here reproduced from 'Rural building traditions on Bornholm' by Niels-Holger Larsen.

Above bottom, figure 21: Detail of post, tie beam secured by two pegs through the wall plate and the lower part of the rafter. The method of using tusk tenons was abandoned after the late 1700s – except on Bornholm where it, as here, appears in the very last timber framed houses from the late 1800s.
