Revitalising Building Archaeology

Hacksen Kampmann, Thomas

REVITALISING BUILDING ARCHAEOLOGY

Abstract. The purpose of this study is to investigate whether archaeological building studies can help us estimate the overall life expectancy of building parts for use in Life Cycle Assessments (LCA). At KTR we teach and research how to reuse the existing building stock and, as part of this of course, how to reduce energy consumption in buildings. As buildings account for a very large part of our total environmental impact, and because we believe that older, energy-optimised buildings have a much lower overall environmental impact than building new, it seemed obvious to take an interest in making accurate calculations of buildings' total environmental impact. Especially the comparison between brand-new high-insulated buildings and older buildings that usually cannot be pre-insulated to such a high standard – but where, on the other hand, the physical building already exists.

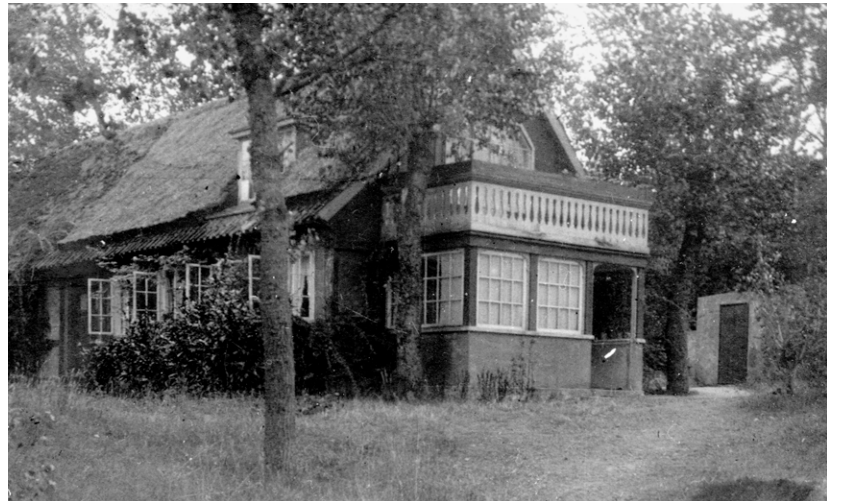
Previous page, figure 1: Example of different colour layers on an inner door, work done by the conservator. **Above, figure 2:** Historical view of the house, as seen from the north. Bornholms Ø-arkiv. **Middle, figure 3:** 'The Apprentices' House' as it appears today with corrugated fibre-cement roof, emulsion painted walls, plinth and timber-framing, of which some is applied directly on the wall. **Bottom, figure 4:** Marking of horizontal level with water hose – the surface of the water is at the exact same height at both ends of the water hose.

Two other 9's in the drawing are also fixed and the cartoonist's 2's are round at the top like his 9's. The drawing seems to indicate that there was a porch already then (Fig. 2) and a door with a window above and railings, suggesting a balcony on top of the porch. Note, that there are no dormers. This indicates that the porch and the extension with two bays were added at roughly the same time, around 1895. Both sections are built with cast foundations.

We set up two scenarios for the calculations: Scenario I, in which the project was carried out as if the building had been protected, i.e. a restoration with the least possible interference with the existing building, roughly similar to the looks shown on the two old photographs (Fig. 2); and Scenario II, in which we imagined it as renovated by architects/technicians/engineers/craftsmen in the usual way.

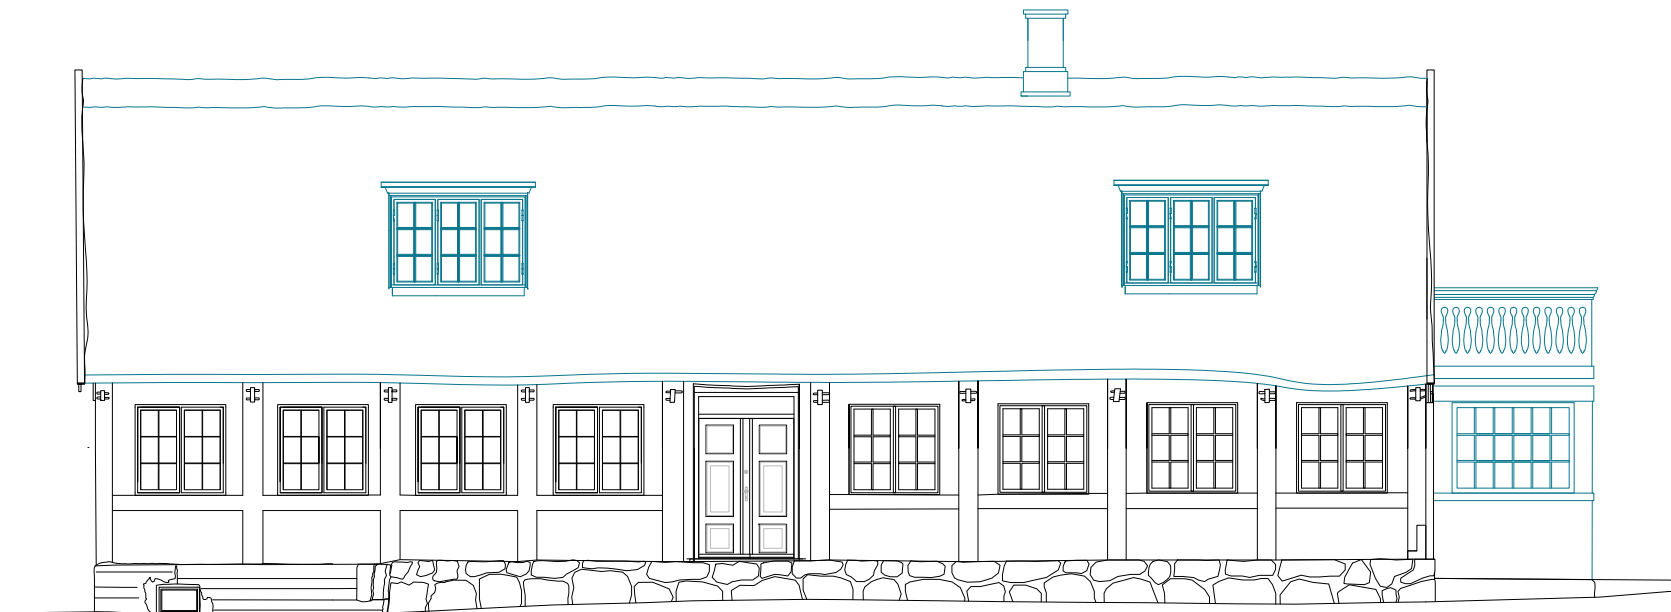
Below, figure 13: Overview of the historical stages of the building.

Historical stages	Colour	Owner	Building changes
I 1887 – 1888	Red	Emil T. Bohn	Erected, 7-bay, 4-bay living room and 3-bay stable
II 1888 – 1912	Orange	August O. Funch	The stable is expanded by 2 bays and the porch built sometime around 1895
1912 – 1913		Mathias C. Funch	
III 1913 – 1947	Green	Martin Silberstein	1916 1920 + stairs and dormers for a room course north-west of the stairs on the 2nd floor and an extension in full wall towards the sw.
IIII 1947 – 1967	Blue	O., A. & C. Andersen	
V 1967 – 1999	Indigo	Knud Fiil	Housing and rental for barmaids Maybe the chimney was gone with dormers Water damage 1973–74
VI 1999 – 2017	Violet	Bill R. Hansen	Reception for rental of holiday apartments
VII 2017 -		Dansk Håndværk
