Revitalising Building Archaeology

Hacksen Kampmann, Thomas

Hacksen Kampmann, T. (2020). Revitalising Building Archaeology. In C. Harlang, M. B. Mortensen, & V. B. Julebæk (Eds.), *Hands on: The value of building culture* (pp. 62 - 73). GEKKO Publishing.

REVITALISING BUILDING ARCHAEOLOGY

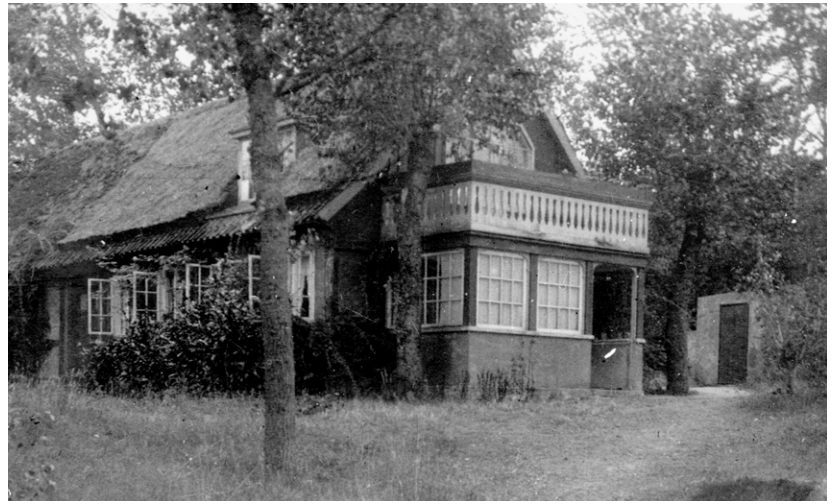
Previous page, figure 1: Example of different colour layers on an inner door, work done by the conservator. **Above, figure 2:** Historical view of the house, as seen from the north. Bornholms Ø-arkiv. **Middle, figure 3:** 'The Apprentice's House' as it appears today with corrugated fibre-cement roof, emulsion painted walls, plinth and timber-framing, of which some is applied directly on the wall. **Bottom, figure 4:** Marking of horizontal level with water hose – the surface of the water is at the exact same height at both ends of the water hose.

Two other 9’s in the drawing are also fixed and the cartoonist’s 2’s are round at the top like his 9’s. The drawing seems to indicate that there was a porch already then (Fig. 2) and a door with a window above and railings, suggesting a balcony on top of the porch. Note, that there are no dormers. This indicates that the porch and the extension with two bays were added at roughly the same time, around 1895. Both sections are built with cast foundations.

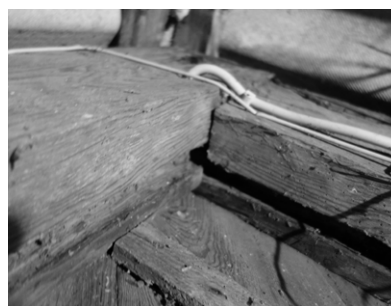
Figure 9: Construction detail at north-western gable. Here, the rafter is made from pinewood and provided with a groove originally intended for the attachment of gable boards. The pinewood rafter is typical to roof constructions and in contrast to the other rafters, presumably made from poplar. Photo, Thomas Kampmann, 2019.

established that the boards had not originally been nailed on the outside but instead notched into a groove in the rafters themselves. (Fig. 9) No timber marks were found on this rafter, but the next rafter had ‘VI’ scratched into the wood. (Fig. 10) This rafter and the next ones were all numbered in a descending scale down to No. I. The rafters were roughly processed with an axe and not made from pine, as is normal practice, but presumably made from poplar. The collar beams that were preserved were also numbered and made from the same type of wood as the rafters. (Fig. 11)

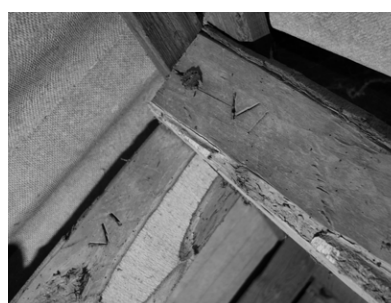
Figure 10: The top joint of rafters in the roof construction in the apprentice house. The timber mark, here on rafter no. VI, indicates a seven-bay house of two gable in pinewood rafters and 6 numbered rafters in between in poplar. Photo, Thomas Kampmann, 2019.

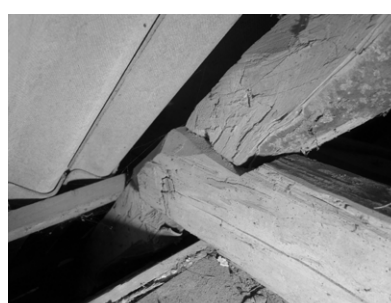
Figure 11: Joint between rafter and collar beams. The rafter and the collar beams are made from the same type of wood.

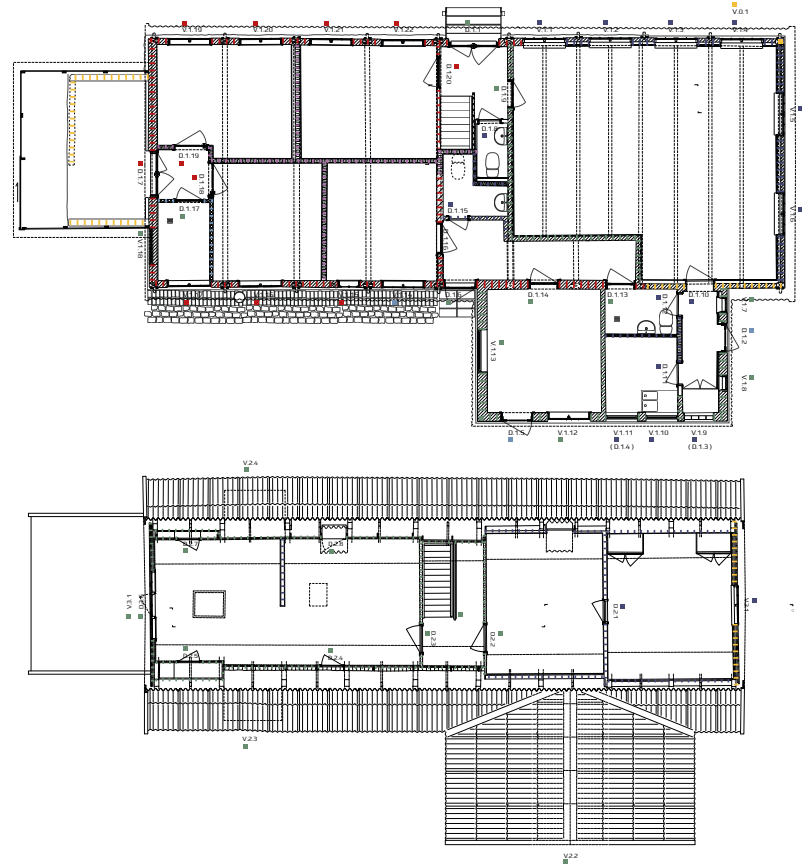
Above, figure 12: Historical building changes over time. The colours on walls, doors and windows indicate how old they are – the red ones are the original from 1887, the orange are extensions from about 1895, the green from after 1916, the blue ones from after 1947, indigo from 1967, and purple is 1970s remodellings.

The oldest windows and doors are all assembled with mitre joints, and thus planed by hand, as well as with hand-forged steel. This dates back to an older age but the number and proportion of fillings on the doors confirm that they are from the late 1800s. (Fig. 12, 13)

The drawings show Scenario I, the restored house, where most of the recent alterations (the purple colour in figure 12) have been removed, such as the interior plaster walls, the plywood-covered north-west gable, the shed here as well as the roofing.
